NPIC/R-1452/63 September 1963

PHOTOGRAPHIC INTERPRETATION REPORT

CONSTRUCTION ACTIVITY CAYO FRANCES, CUBA

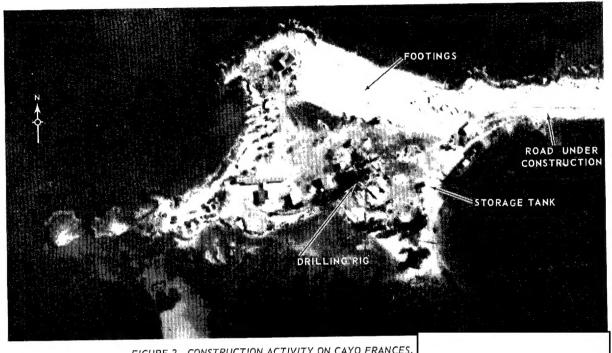
FIGURE 2. CONSTRUCTION ACTIVITY ON CAYO FRANCES,

photographic coverage revealed unidentified construction activity on the western tip of Cayo Frances (22-38N 79-13W) consisting of a series of footings in an area approximately 370 by 30 feet. These footings have been completed to form 30 rows of 5 footings each, but no additional activity has been observed there through and the exact purpose of the footings remains undetermined.

However, since _______ the construction of a drilling rig has been observed south of the footings (Figure 2). On ______ this lattice-type rig appeared complete, measuring 195 feet in height. A small vertical storage tank with a diameter of 20 feet has been constructed 350 feet east of the drilling rig.

In addition, road construction leading east along the northern coast is probably associated with oil exploration activity, and ground scarring at the terminus of the road (not shown in Figure 2) may be the future location for an additional drilling rig.
